Minutes from "The International Restoration Camp in Kuldiga", Latvia, 29th of June - 5th of July 2009

Kuldiga hosted a new workshop the 29th of June to the 5th of July 2009 to enhance the competence of the craftsmen in town. This time the topics were doors, windows and window shutters. There were participants from Finland, Denmark, Sweden, Latvia and Norway.

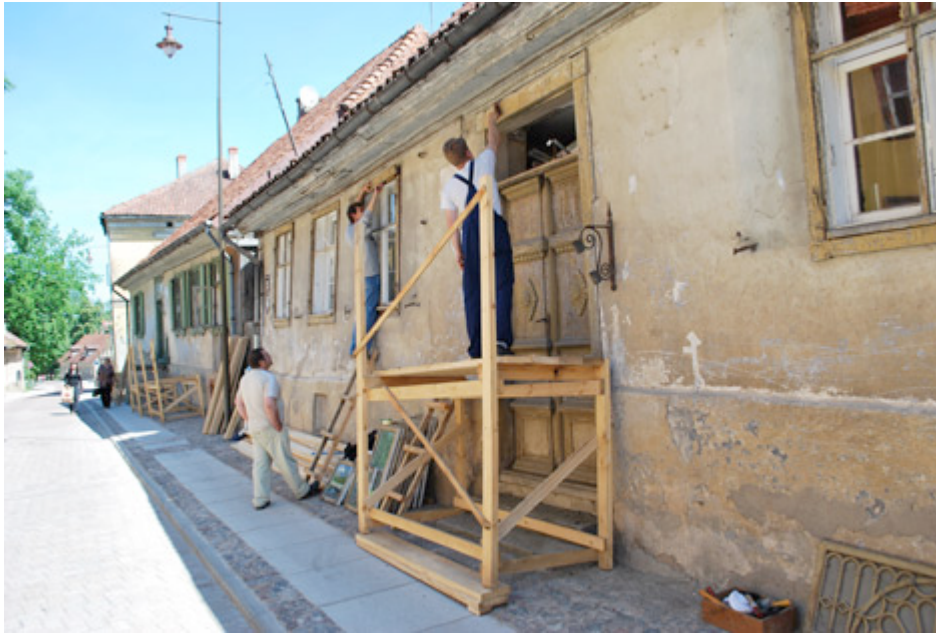
Works in Kalna street.

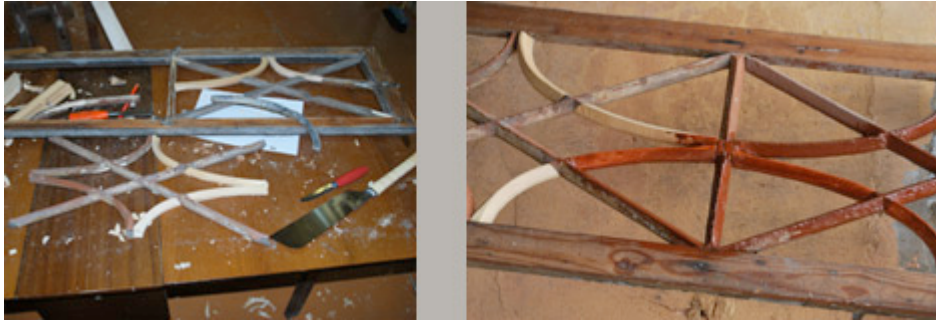
Window above the door in Jelgava street 9.

The window above the door was in good condition. It was washed and rinsed. Later basic treatment as painting was made, and the old glass panes were sealed with putty. A few panes had to be replaced and they were cut from old glass panes. The window above the door in Jelgava street 9 had been removed, and was in a very poor condition, but nearly complete. Several profiled cut glazing bars had to be copied. Originally, the window had 8 small panes. However, at some time in the past, the top of the glazing bars had been removed and one large glass pane had been mounted instead. The decorating flower in the middle was missing, but was copied from an old image, and from an equivalent window on a neighbour's house. It was all rinsed and painted.

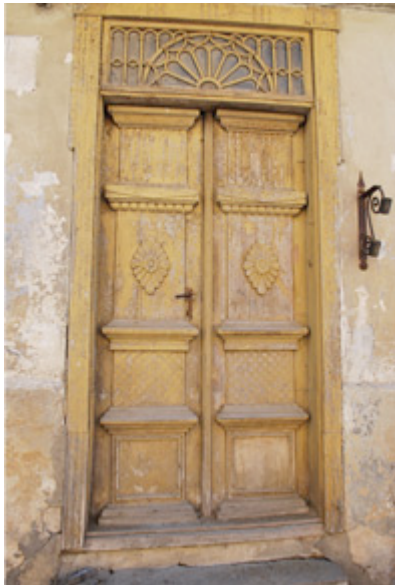
The door in Kalna street 15.

The door in Kalna street 15, a double door from 1780-1800 had been extended downwards 50-60 cm at around 1900, in connection with the restoration of the flight of the street, and the removal of a small staircase. The door was not in use, but was in good technical shape. All details and changes/developments were registered and the door was scraped carefully, washed and given a basic treatment using linseed oil paint. The window above the door was also in good shape. It was demounted, washed and given a basic treatment. The wall, window, door and mouldings are now given back the original colour of the house from earlier periods. The house is included in a project, where the whole street will be given back the original colours. This is the first restored house in the Kalna street, and will be an “exhibition window” for the project.

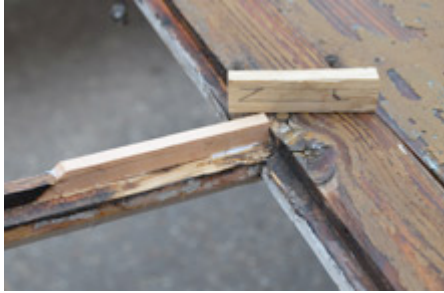
Restoration of glazing bar.

The window frames in Kalna street 15 were mainly in good shape. Some loose tops of the glazing bars were replaced and some corner connections had to be made new, using good techniques for insertion, where as little as possible of the old materials were removed.

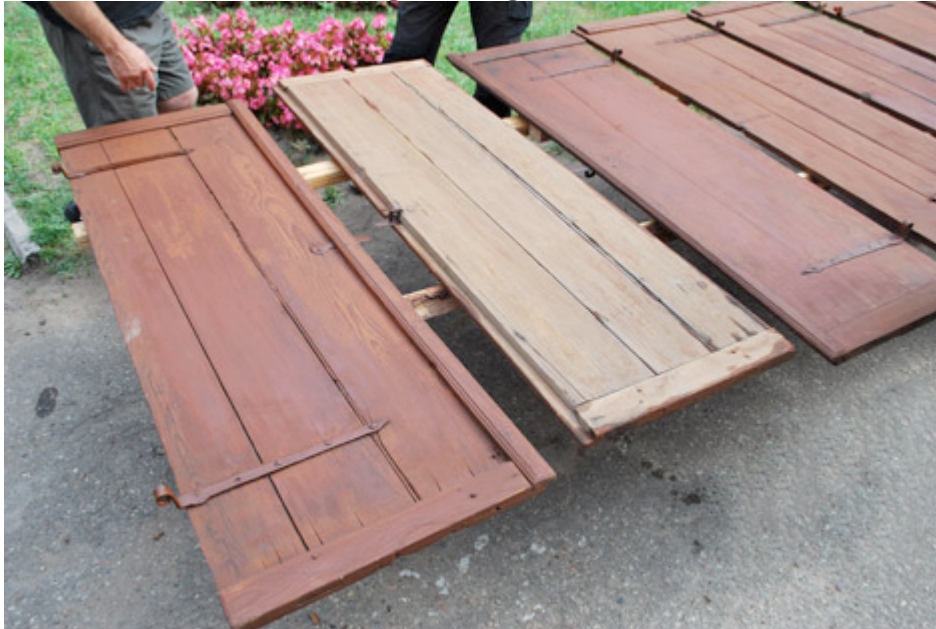
The window shutter

The oldest window shutter is composed of 2-3 wide standing boards, and had attached a horizontal profiled thin list on the top and bottom. The vertical boards are fitted into a groove, to stabilise the curving, and the bottom and top lists were fastened using an extended tap, locked by wooden plugs. On newer shutters, but still old, the boards width is smaller, but the construction is relatively similar. We saw fresh copies where screws had replaced the wood connection. There are also a few examples where the shutters are made in framework construction. We also found a house with integrated cone horizontal board, in the same position as the hinges.

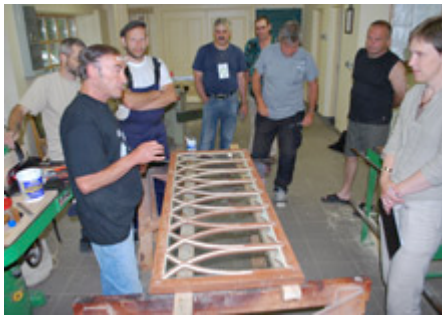
Sessions and demonstration of glass cutting and how to use putty, when fastening the glass.

During the workshop, we had sessions where we all met to see how the different groups worked, and choice of solutions were discussed. The demonstrations of glass cutting and the use of putty when fastening the glass panes were given. In Kuldiga we see today, nearly only glass panes fastened with thin triangular wooden lists. In connection to the ongoing restoration work, all window glasses are sealed with putty. This is a technique Gunnar and Knut demonstrated several times.

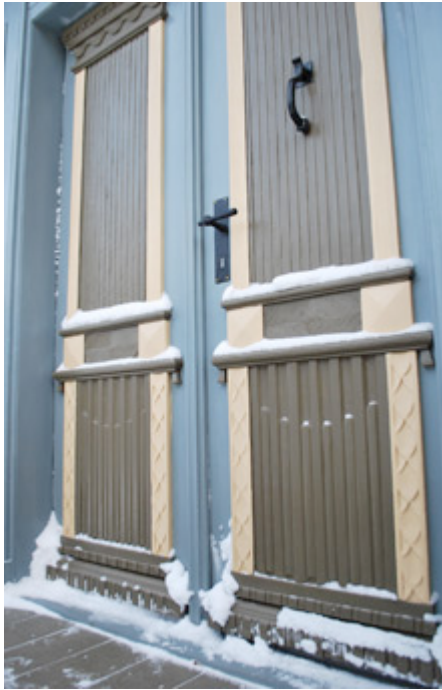
The newly restored door in Kalna street, 15, Kuldiga.

After the International Workshop, summer 2009, doors, windows and window shutters were painted and mounted. Kalna street 15 also got a new staircase to the main entrance. In Kalna street 13 the facade was repaired and painted in the late summer, using a colour found in the old paint layers. The facade of the house in Kalna street 15 and Baznica street 28 is to be painted in the summer of 2010. The houses have been examples for the towns program on restoration of the old wooden town, a town on UNESCOs tentative list.

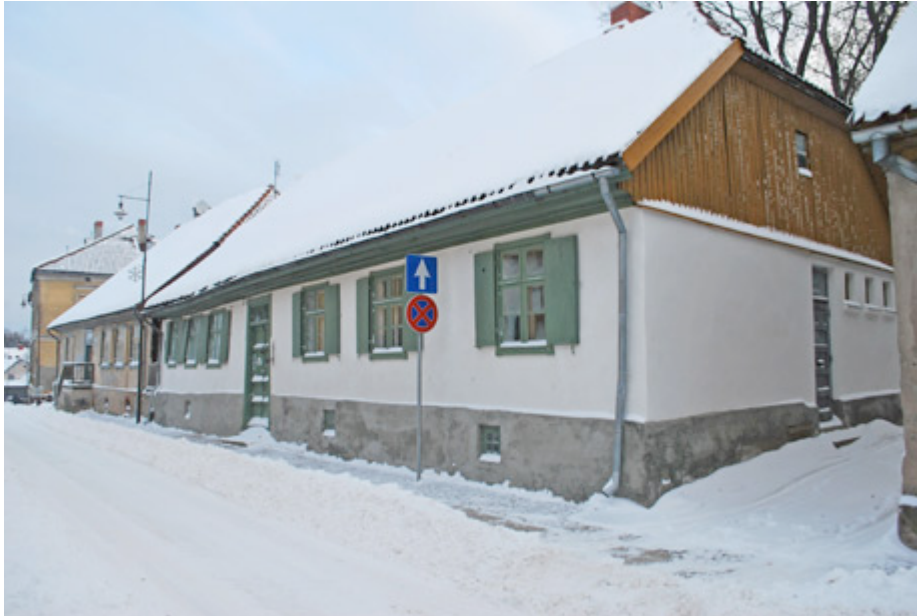
Kalna gate 13, Restored door, windows, window shutters and wall.

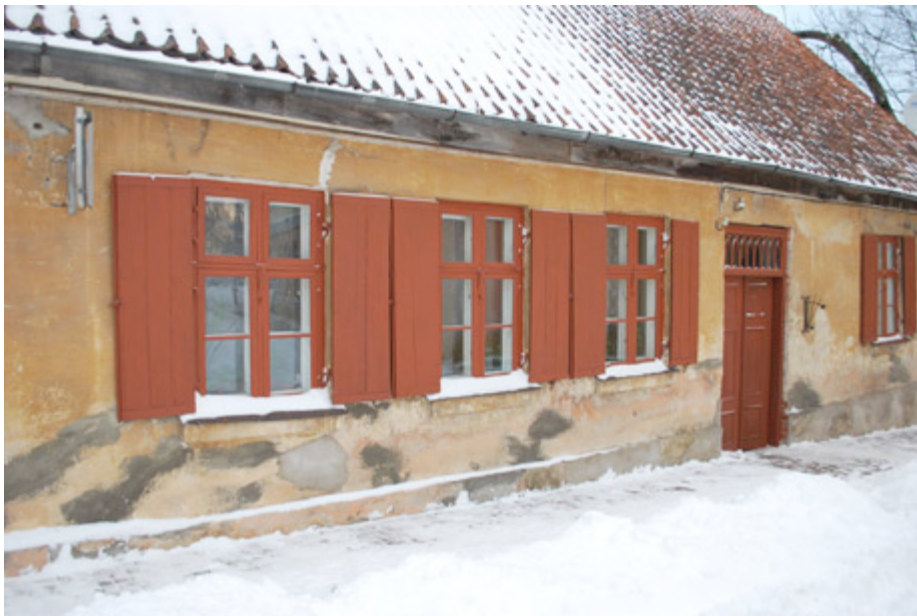
Baznica gate 28, Restored windows, window shutters and doors.

In Baznīcas street 28, the double frame door had been cut 3 cm, had rotten parts in the bottom, and a few broken middle panels. A relatively large reparation work started, with the jointing of new wooden materials of high quality, to get the door back into a good shape. In addition, the frame, which was left in the house, needed a new threshold.
